FEE 009 bias failure

DPNC454_02A PCB

FEE 009 test at Biotech

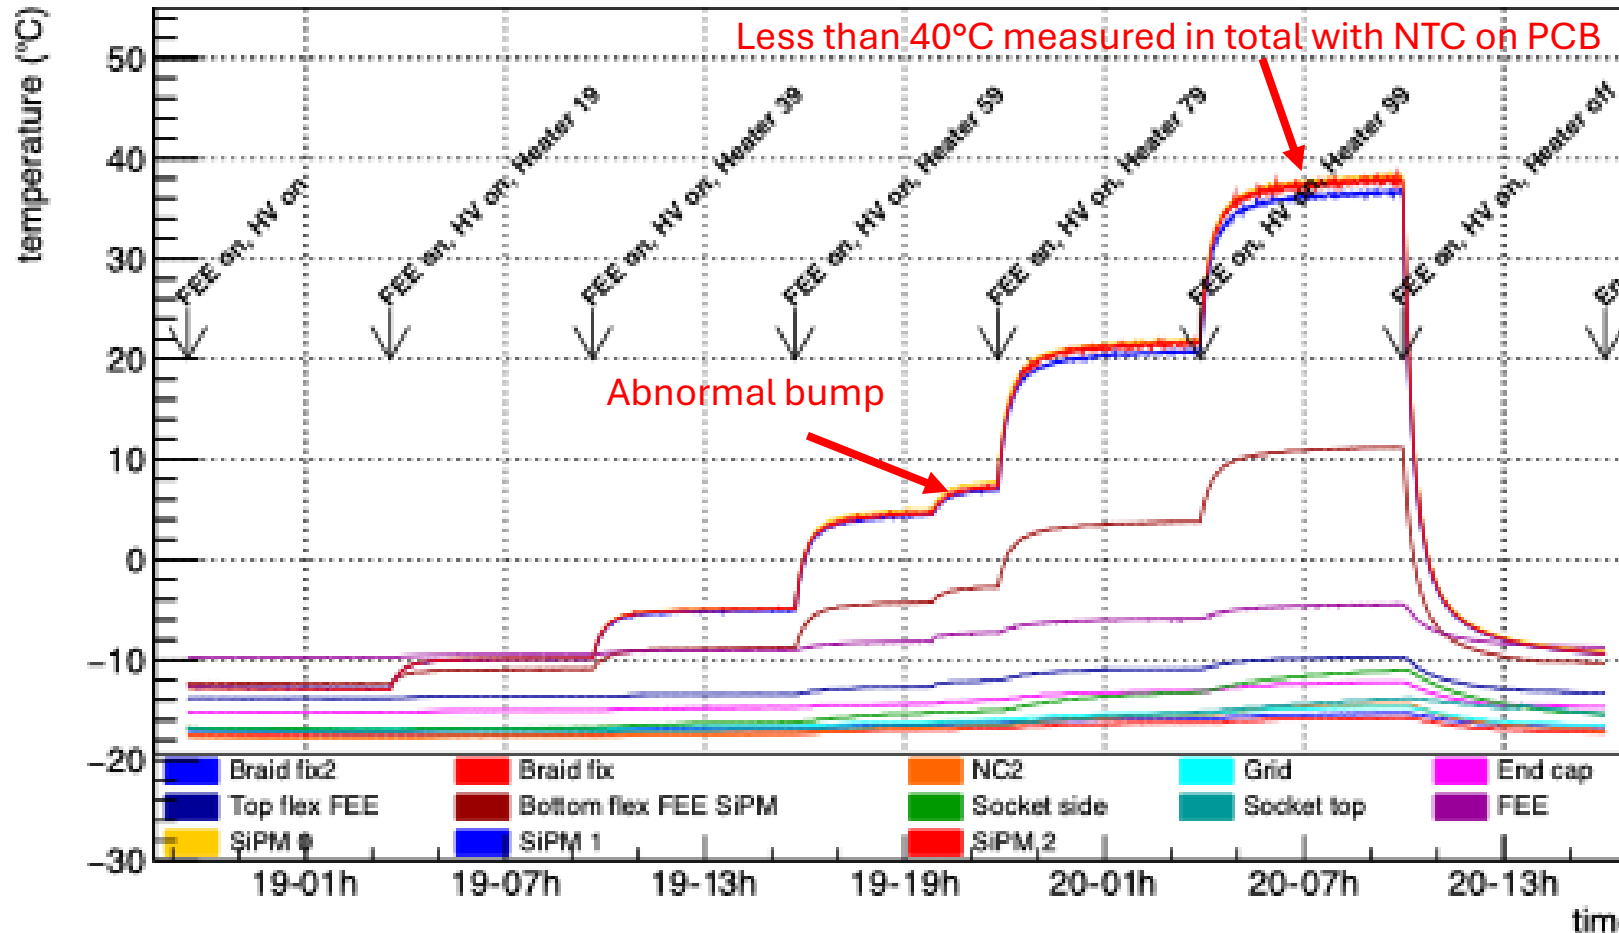
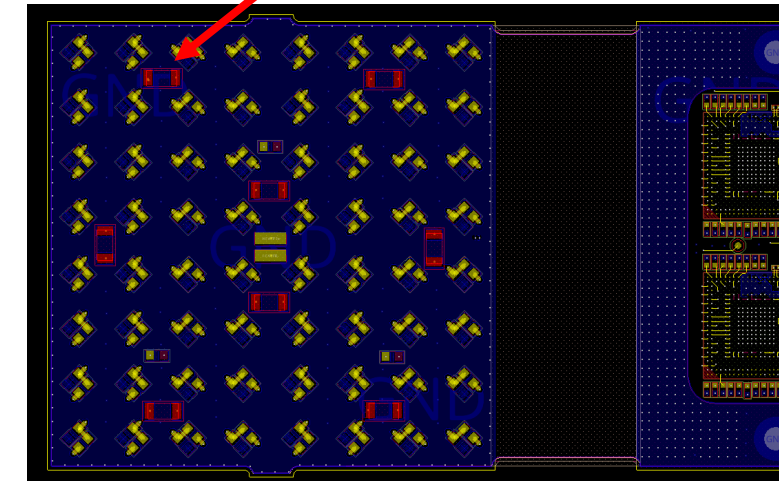
Temperature evolution

Heater resistors in red

- ⇒ PWM voltage steps on heater resistors voltage mounted on the PCB (PWM control value 0, 19, 39, ... 99%)
- ⇒ 100% power = 2W max balanced over 8 x 5R11 1206 resistors on Bottom of SiPM arrays (R383-R389, R396)

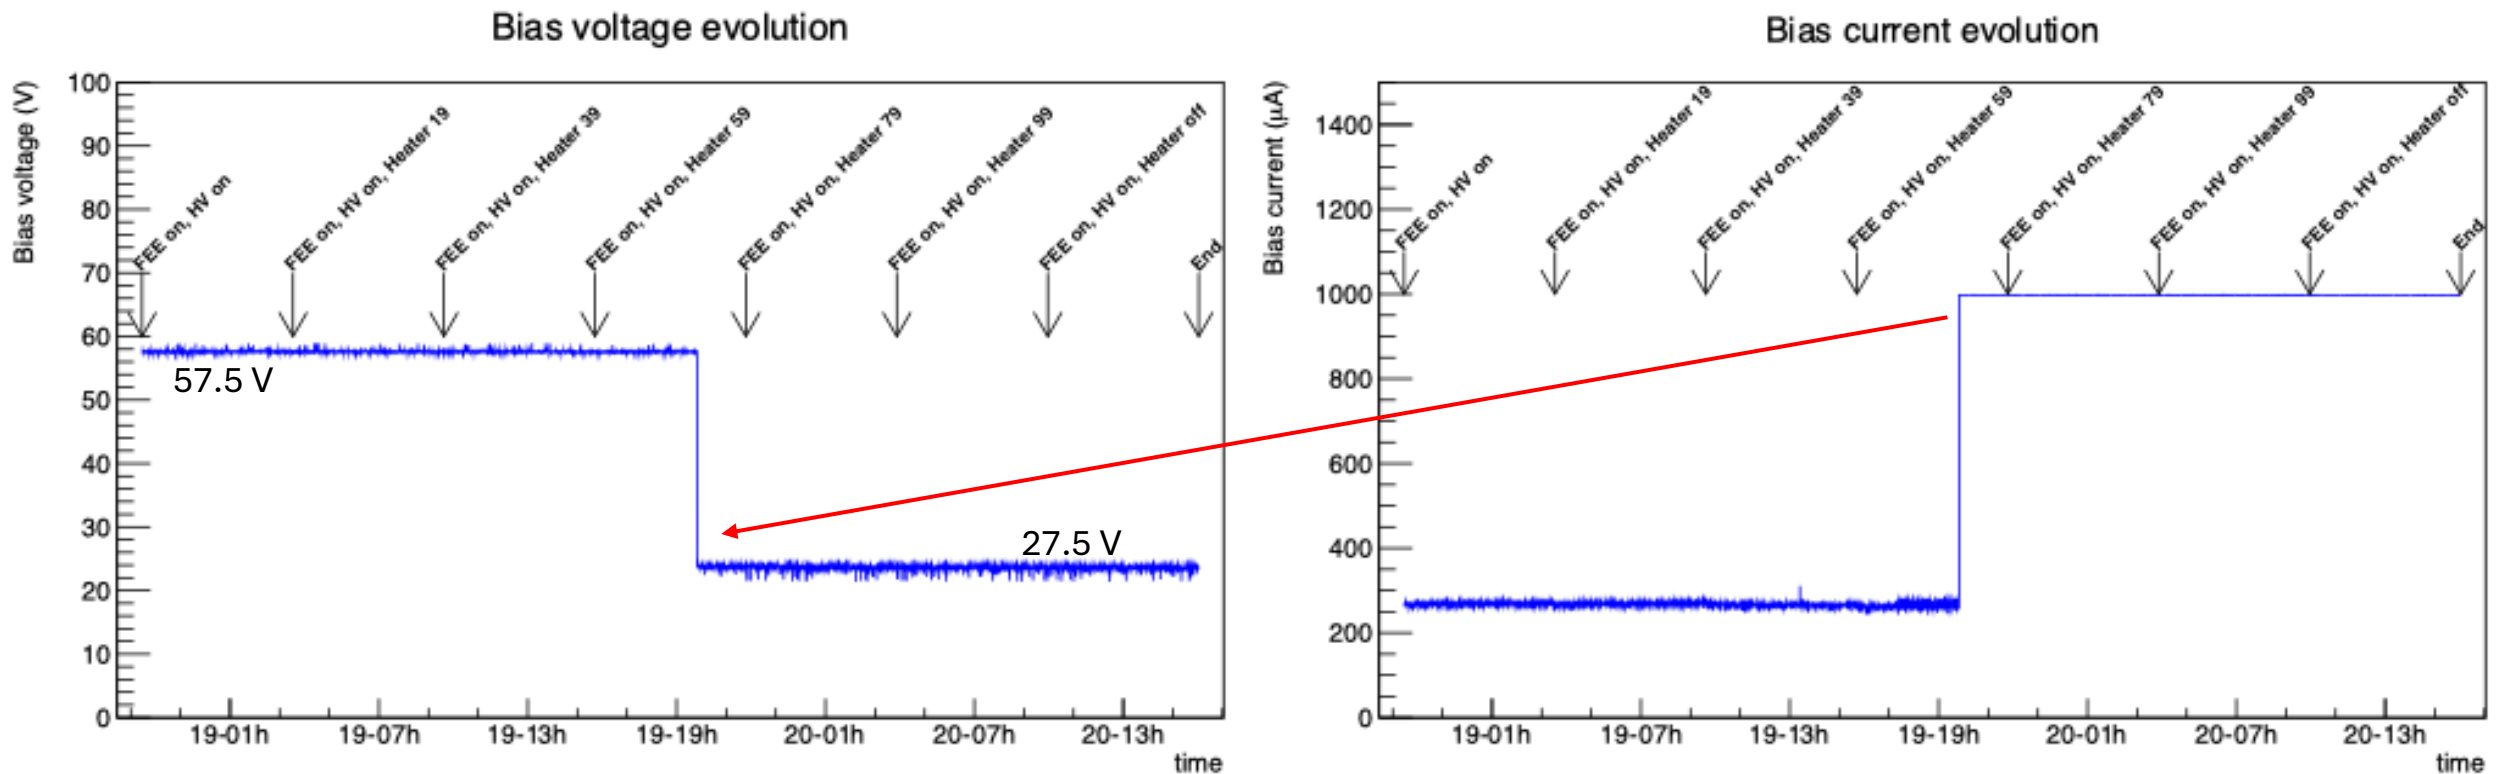
Heater test (19.12 -20.12)

The bias voltage has a current limiter: too much current => voltage drop

During the heating phase with a duty cycle of 59%:

- Temperature of the SiPM sensors progressively increased by 2.5 C.
- Power consumption of the 3V9 line increased by 0.3 W.
- Bias voltage dropped from 53.5 V to 23.5 V.
- Bias current increased to > 1 mA (max. reading of the HK).

→ There must be a short circuit on the HV line, located on the SiPM PCB.

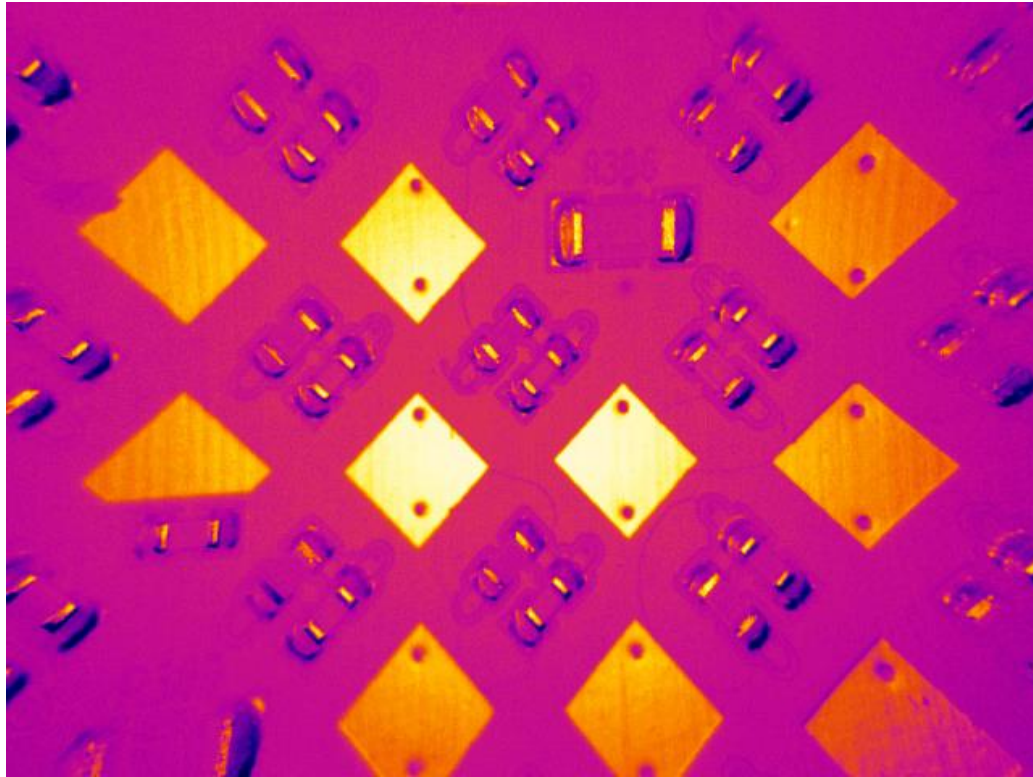
HV off

IR camera: 1K R215 heats when HV is on

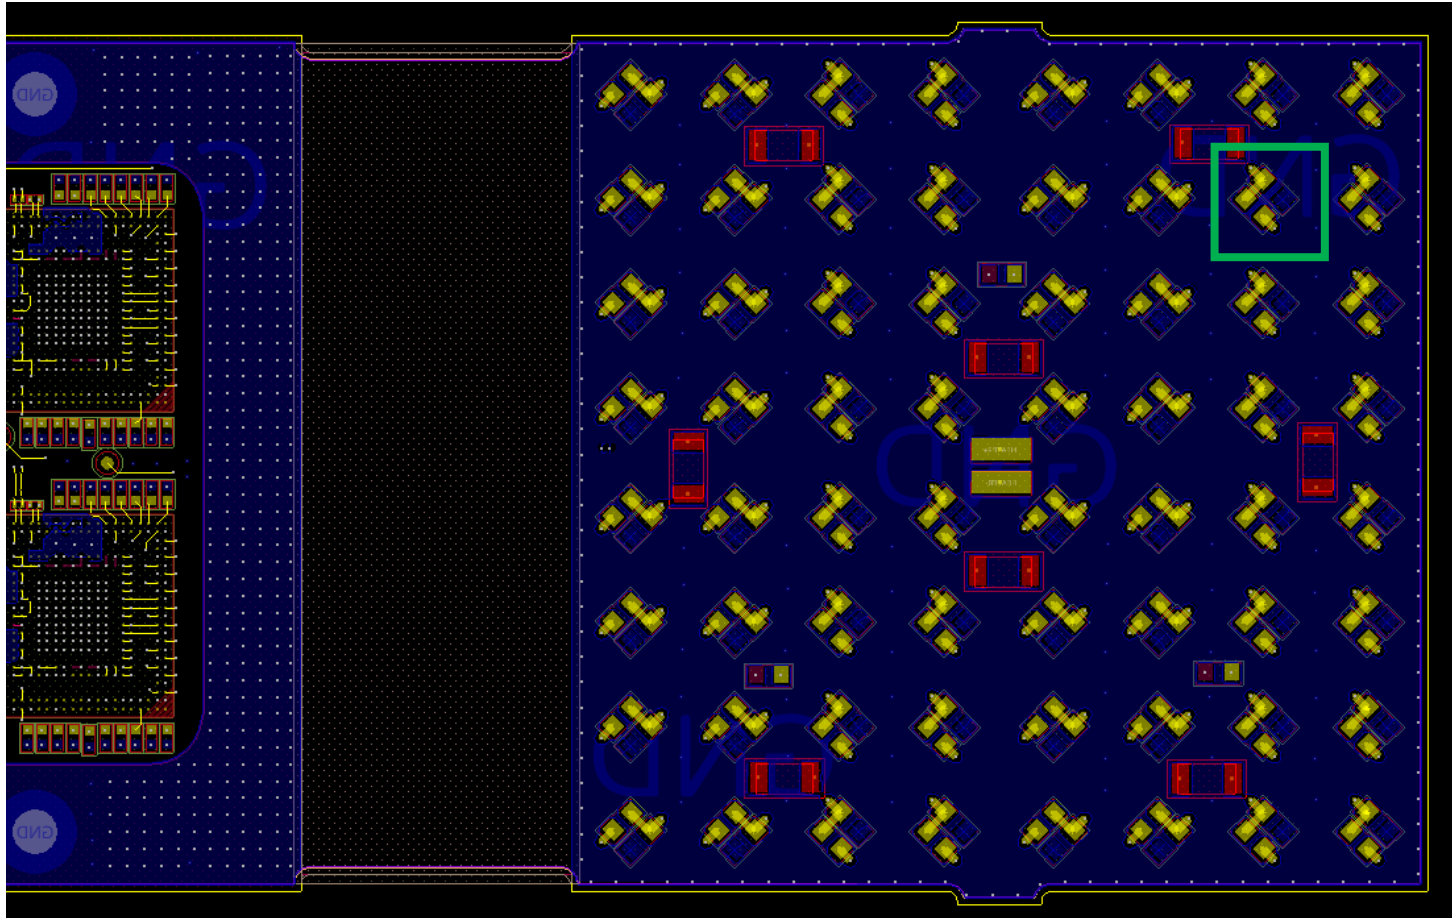
1st supposition : capa damaged

- $R(C444) = 200 \text{ Ohm (HV11-GND)}$: KO
 - $R(R215) = 1 \text{ kOhm (BIAS-HV11)}$: OK
 - $R(C447) = 2.2 \text{ kOhm (HV14-GND)}$: OK
- Only one damaged component.

- Capacitor C444 damaged ?
- If yes thus shorts the HV BIAS to ground through $1\text{K} + 200\text{R} = 1.2 \text{ kOhm}$ (i.e. $\sim 5 \text{ mA}$)
- HV source cannot sustain such a connection to ground.
- HV voltage goes down to some 25 V.
- All the 64 SiPMs are biased below $57\text{V } V_{bd}$.
=> all module channels are dead with this failure

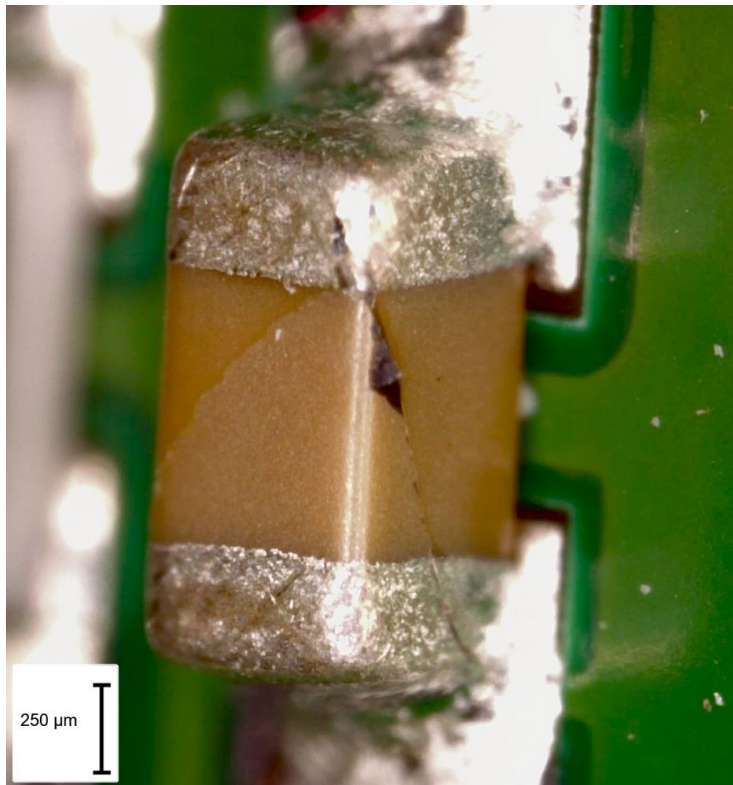
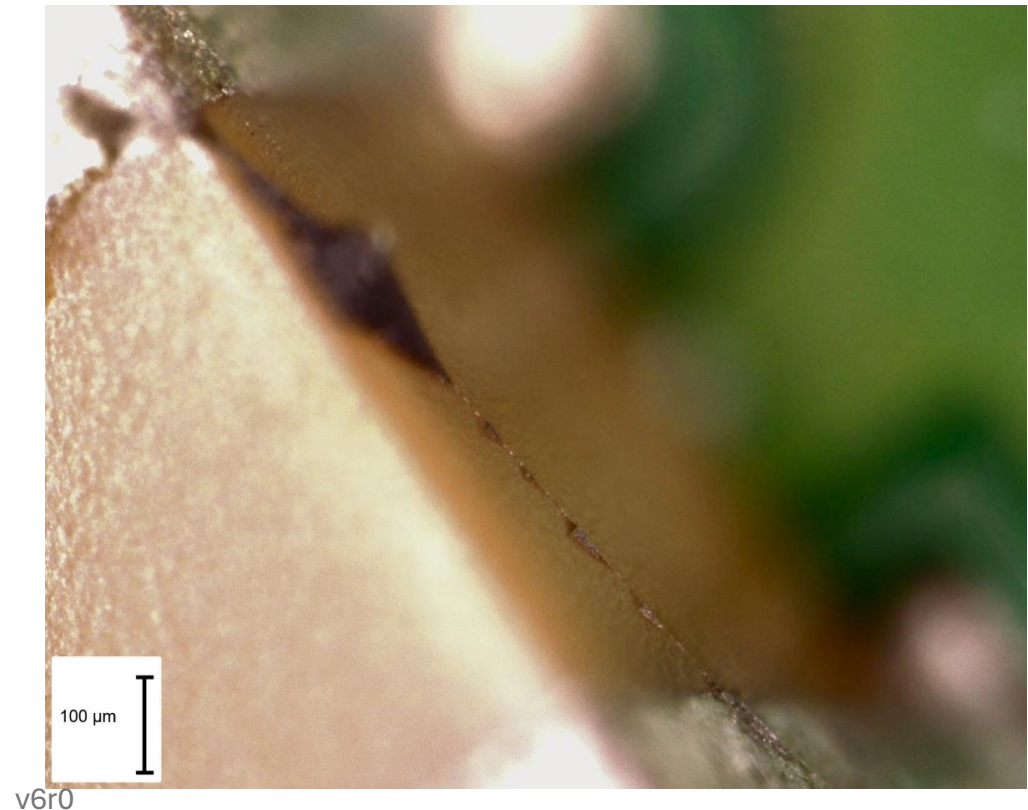
Visual inspection

- The capacitors are of the type CC0603KRX7R0BB104 (0.1 μ F \pm 10% 100V X7R 0603) from YAGEO.
- The CC type corresponds to a “normal” grade, even if the X7R temperature range is extended, from -55°C to +125°C.
- Still, it is not of the automotive type (would be AC0603KRX7R0BB104).
- The same indeed applied to all the components procured by HSA for this production.

- The capacitor *seems* cracked, as show the pictures below. We can also note some resin deposits. To be understood if this ok.

- C444 has been replaced.
 - Remark: the removed cracked capa did not break during removal.
 - The resistive connection to ground is still present.
 - Various tests have been done, in particular I-V measurements on a good SiPM channel and on the bad one, by removing the 1K resistor and soldering wires to the Cathode and Anode SiPM lines.
 - Good channel shows normal SiPM behaviour.
 - Bad channel shows a too high current when operated in reverse bias.
 - A 200 Ohm resistor has been soldered in parallel between the HV line and GND to simulate the problem of the bad channel: the I-V curves are similar.
- => The SiPM seems good and the PCB seems in failure**

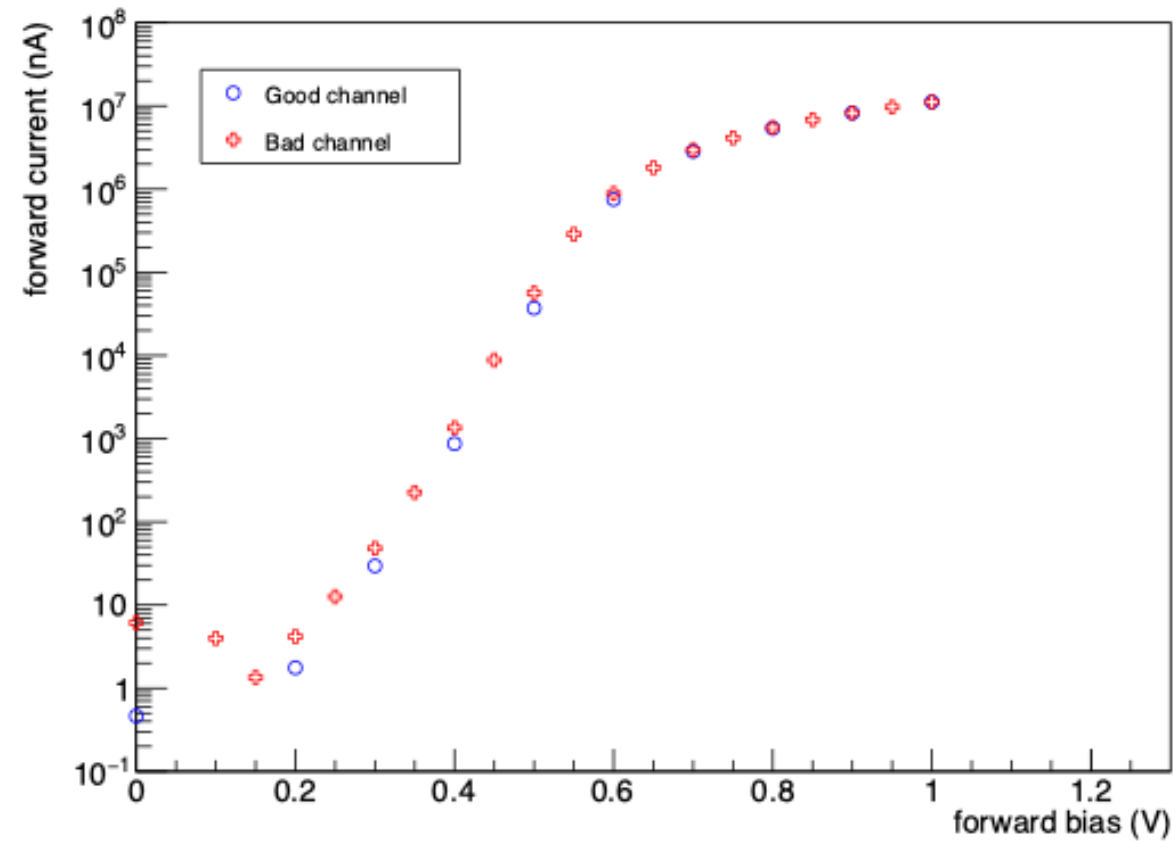
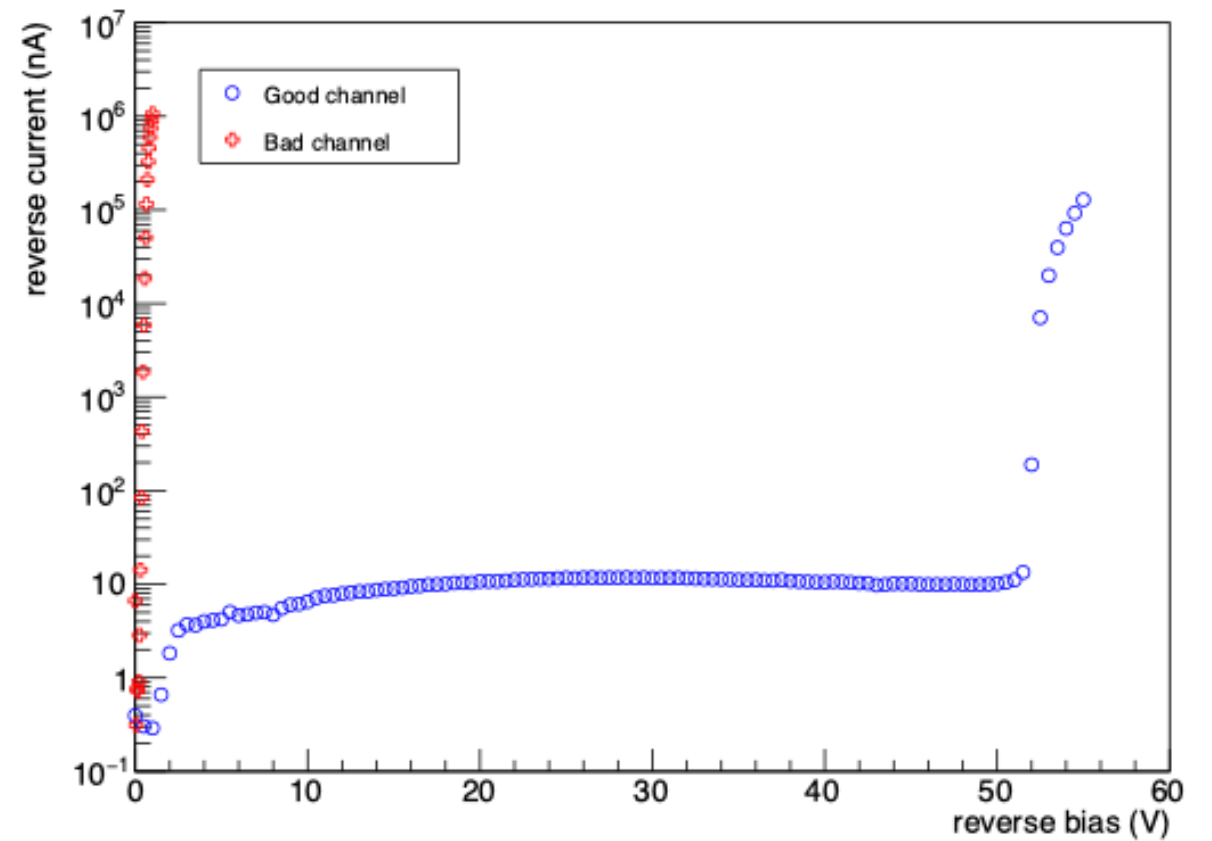
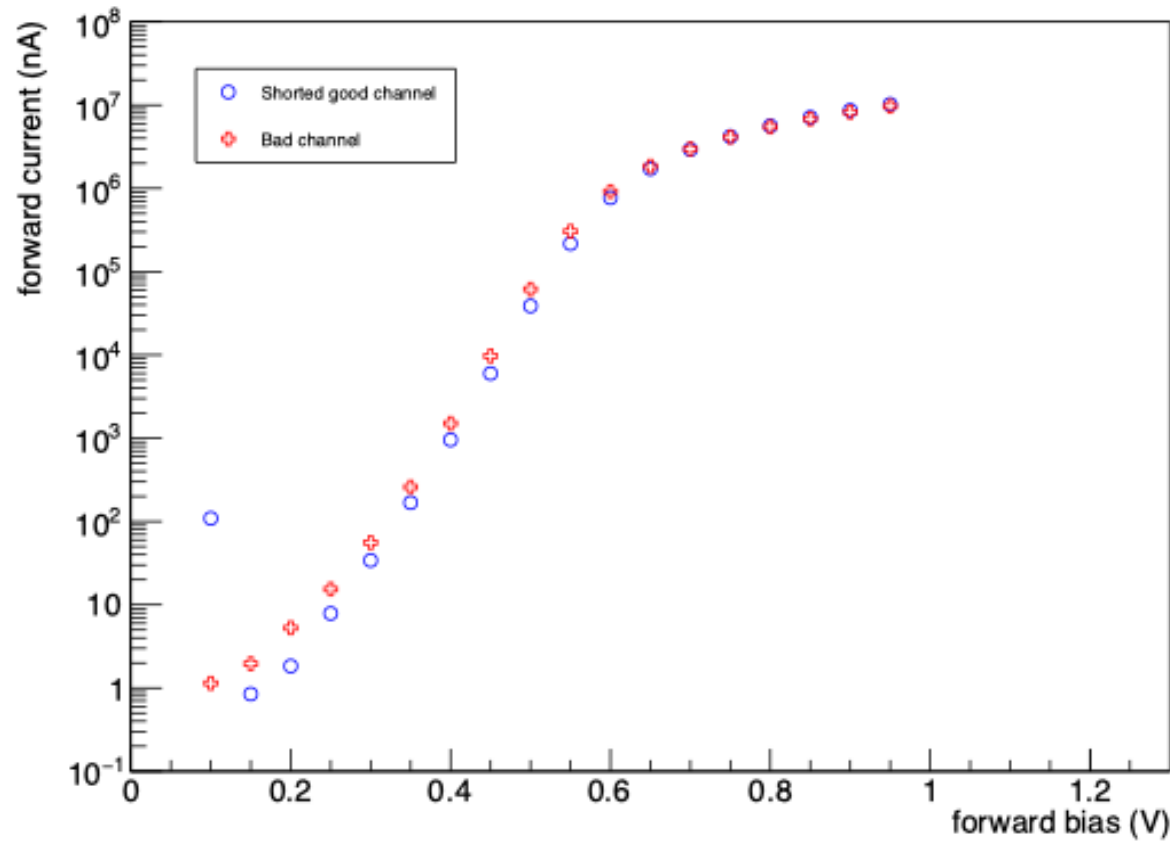
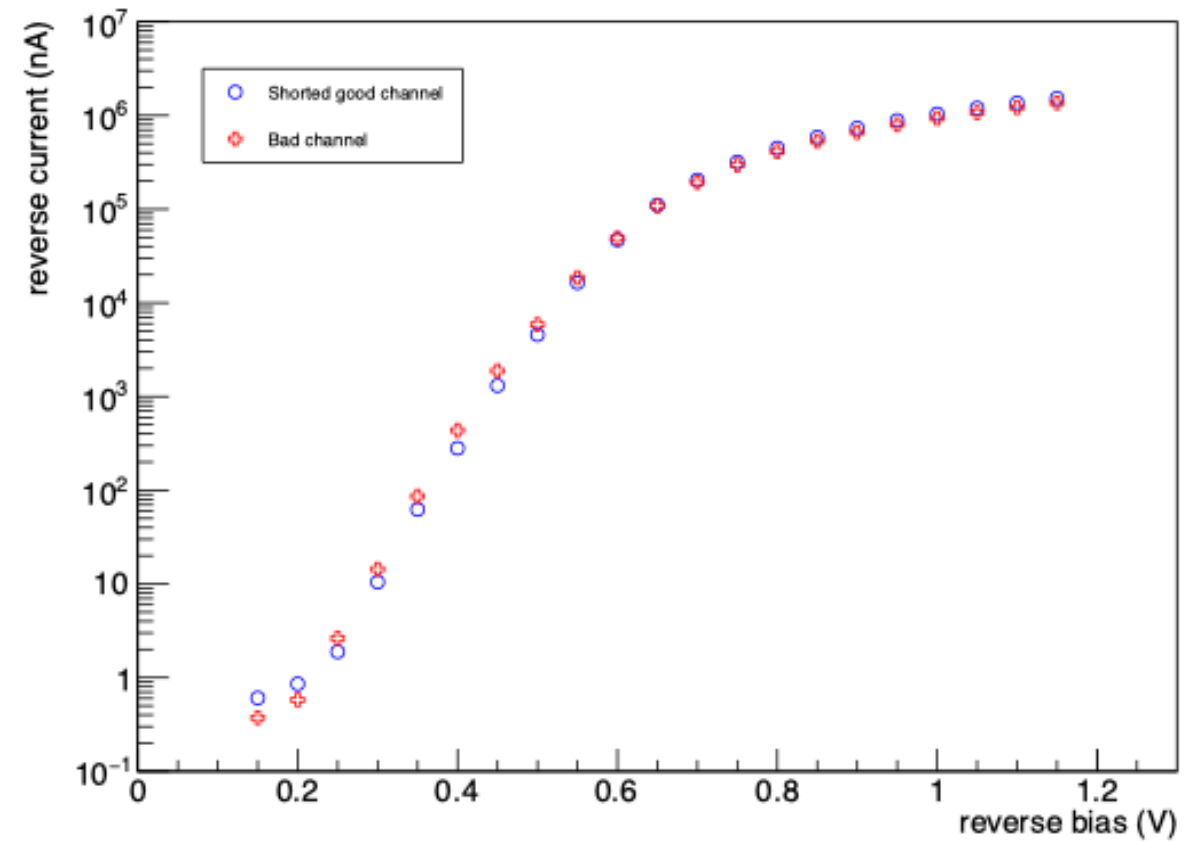
IV SiPM array measurements

=> Same curve on forward and reverse biasing for bad channel and good channel with 200R to GND

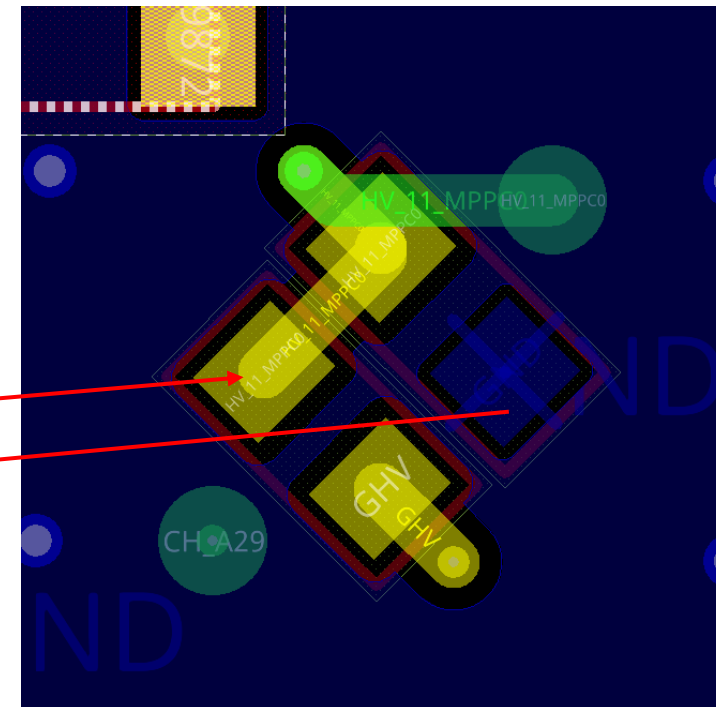
IR with current injection from
Voltage power supply v6r0

- As it is not possible to clearly identify the origin of the problem, we have decided to remove the SiPM array, the capacitor and 1K resistor (only PCB traces remain)
- The array still has to be measured.
- But the resistive connection between the HV11 line and GND is still present on the PCB and now on a very limited area : 1 small trace on BOT (yellow) + 1 through via to TOP + 1 small trace on TOP (green).
- A new IR measurement has been done.
- And X-ray examination has been done.

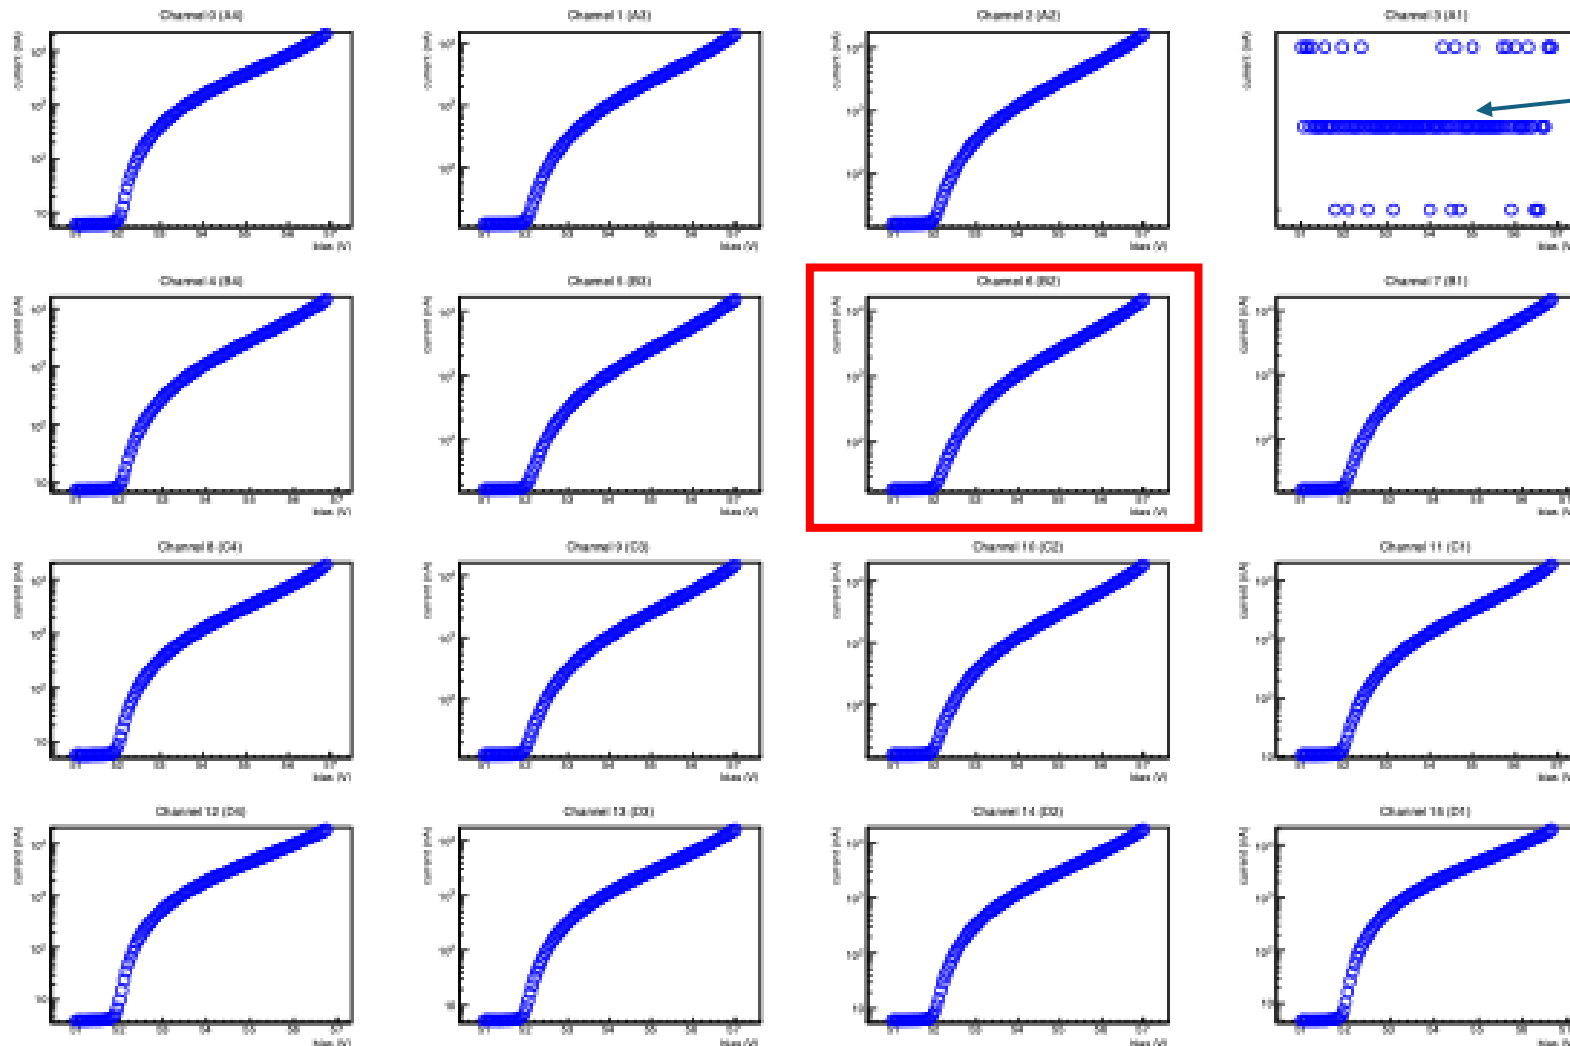
Array I-V curves

Broken pad/
damaged SiPM
during dismounting

Same curve on bad
channel (red rectangle)
=> SiPM is not in cause
=> PCB failure

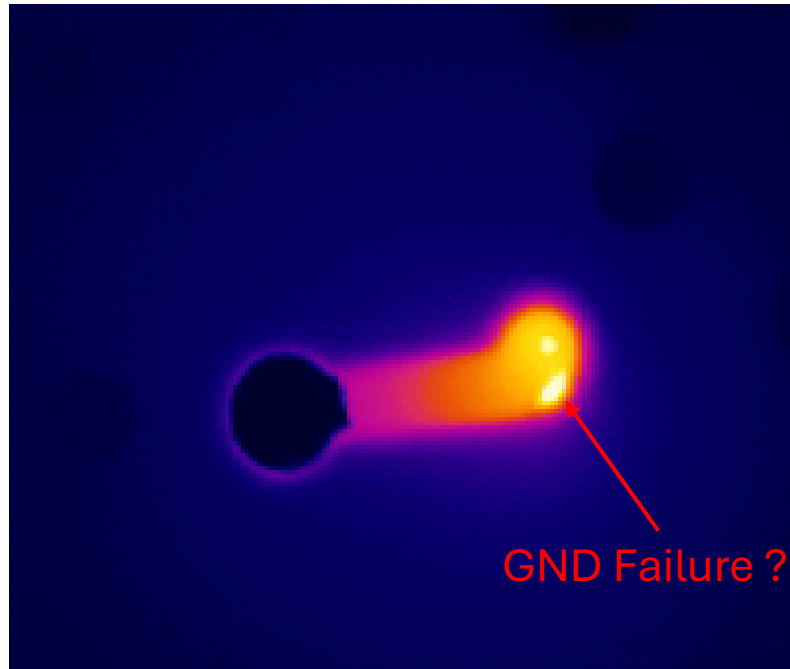
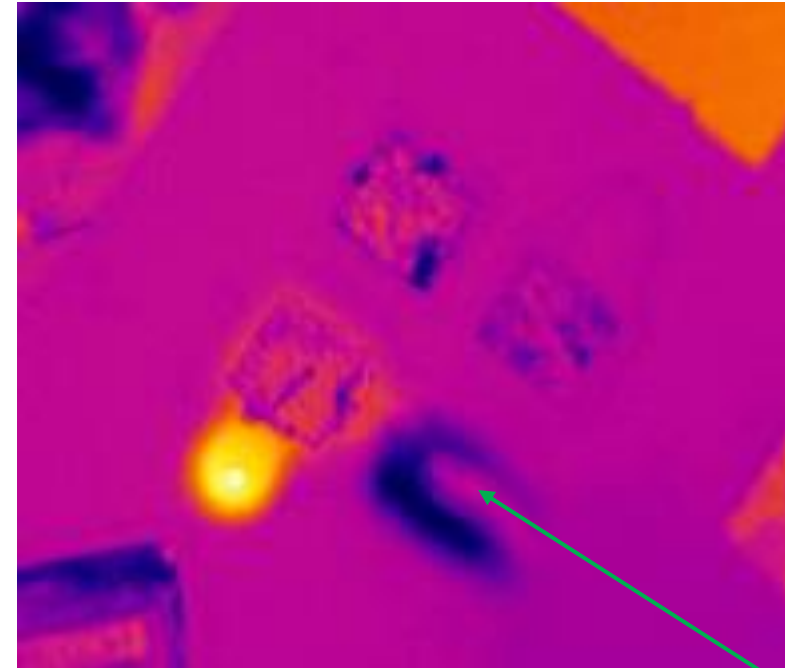
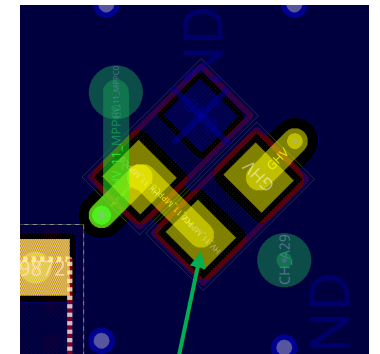
IR camera measurement

Injecting current between BOT trace to GND:

We see current in the via from BOT to TOP and seems the TOP trace corner is shorted to GND

We noted that during that test, the resistance of the connection to ground decreased to some 24 Ohms.

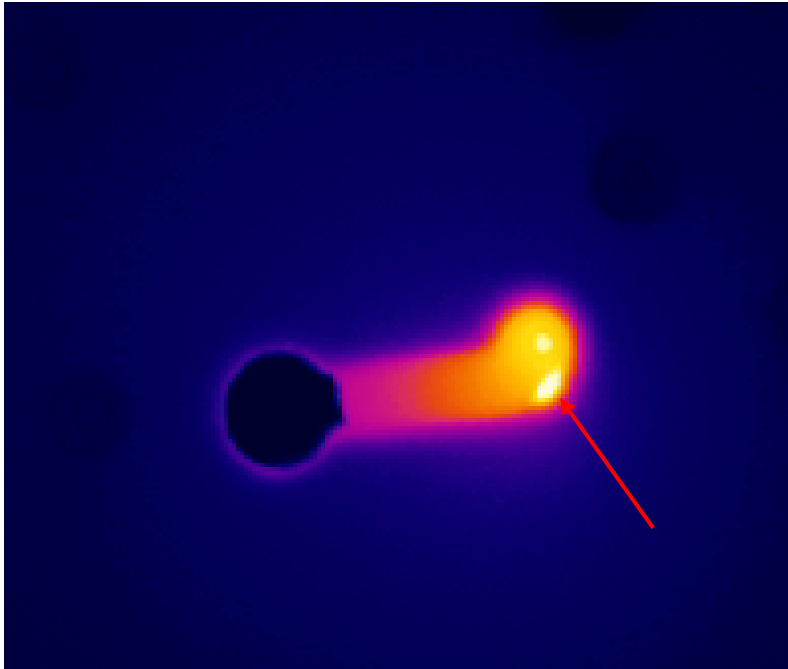
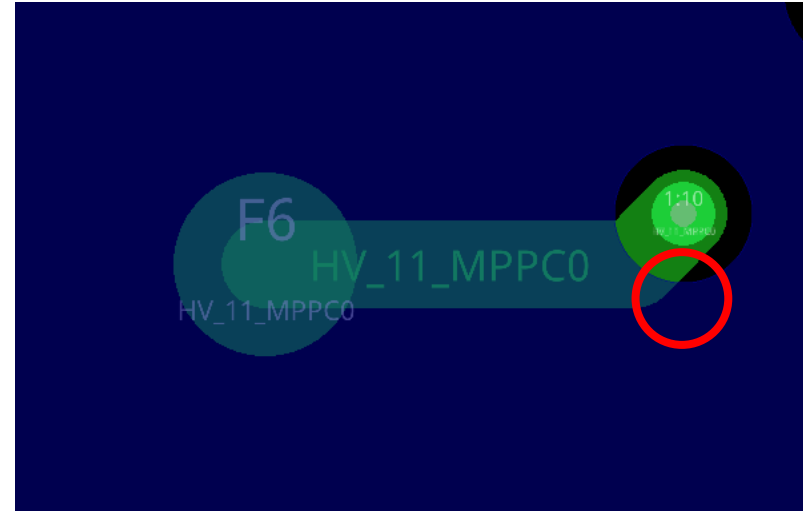
IR camera measurement

Top layer (green) and Layer 2 (GND, blue)

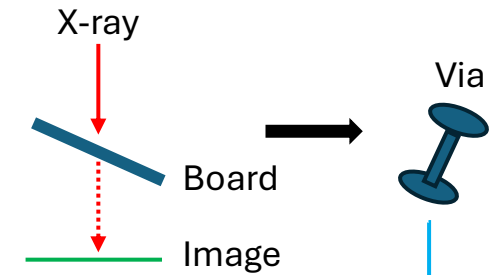
X-ray pictures (board tilted)

Via with the problem, note the material (copper ?) **depletion** close to the “elbow” of the HV line (red arrow).

=> Could it be a CAF issue and this depletion some copper missing due to CAF copper migration in the FR4 from L2 (GND) to TOP (V=57V)?
