FEE 009 bias failure

DPNC454_02A PCB

FEE 009 test at Biotech

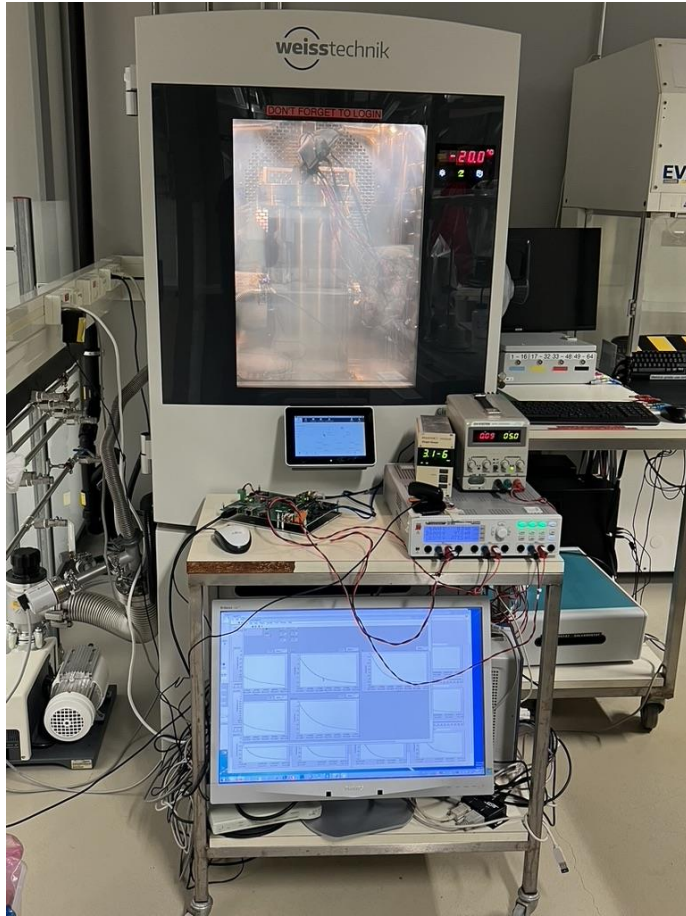
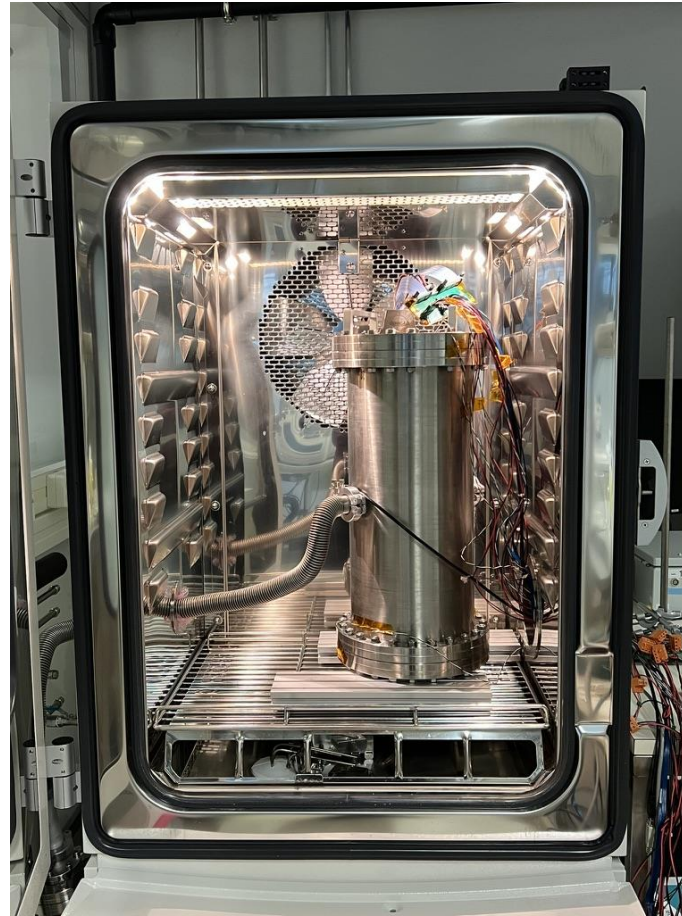
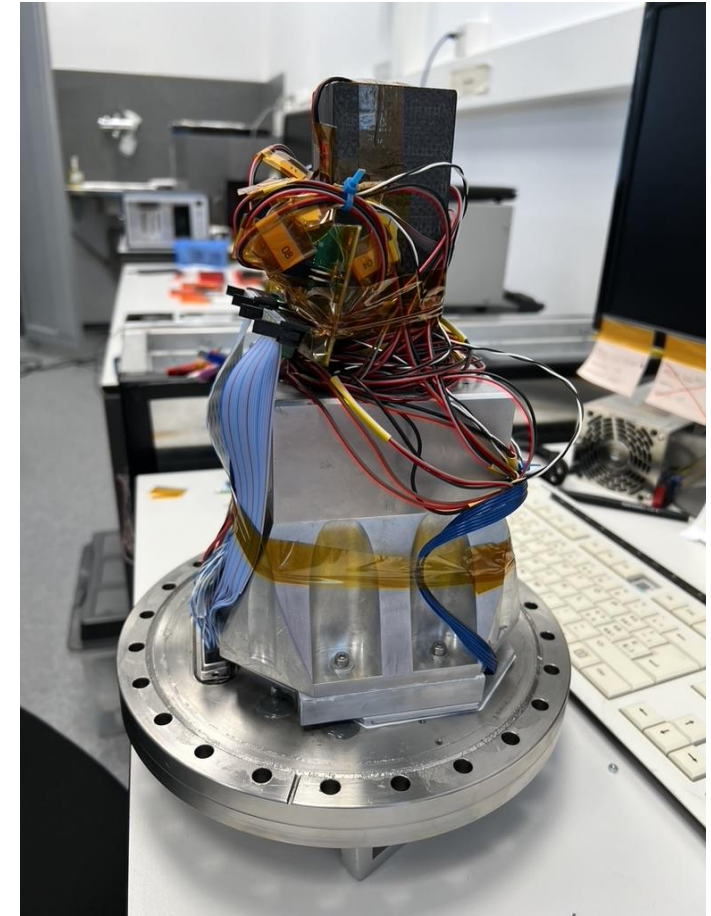
Vacuum and chamber temperature cycling while varying heater resistors voltage mounted on the PCB (PWM control)

HEATER RESISTOR NETWORK for SiPM
 using 0.5W x 8 (1206) and 2W max. applied @ 9V
 $R_{tot}=40.88R \Rightarrow 1.98W @ 9V$
 Thermal connection of the
 ring on the rear side of SiPM
 Soldered with wires to PWM driver

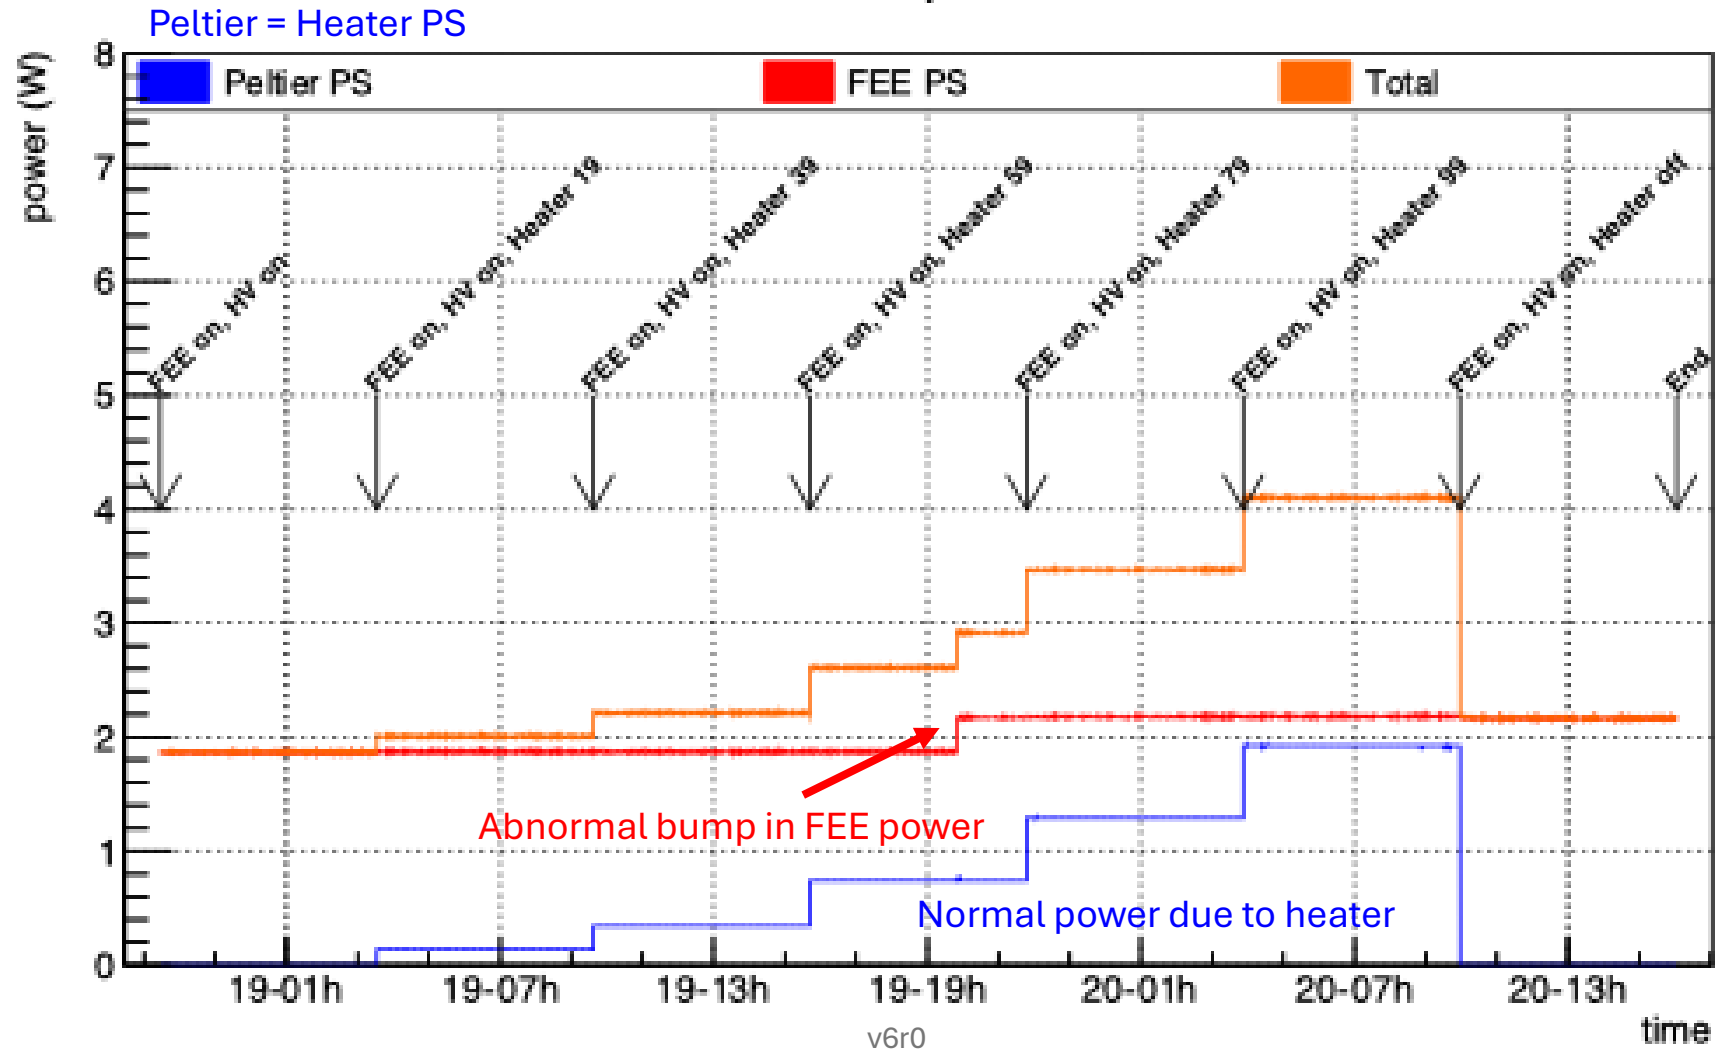
Power consumption evolution

The bias voltage has a current limiter: too much current => voltage drop

During the heating phase with a duty cycle of 59%:

- Temperature of the SiPM sensors progressively increased by 2.5 C.
- Power consumption of the 3V9 line increased by 0.3 W.
- Bias voltage dropped from 53.5 V to 23.5 V.
- Bias current increased to > 1 mA (max. reading of the HK).

→ There must be a short circuit on the HV line, located on the SiPM PCB.

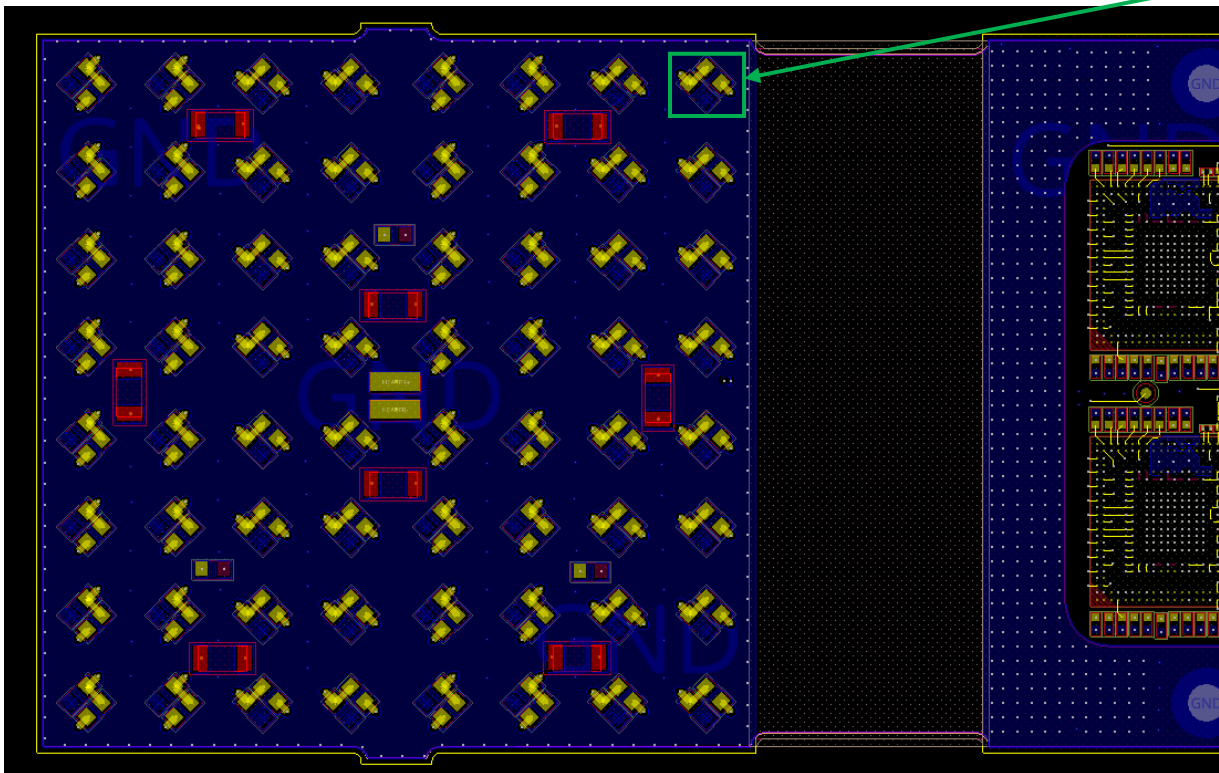
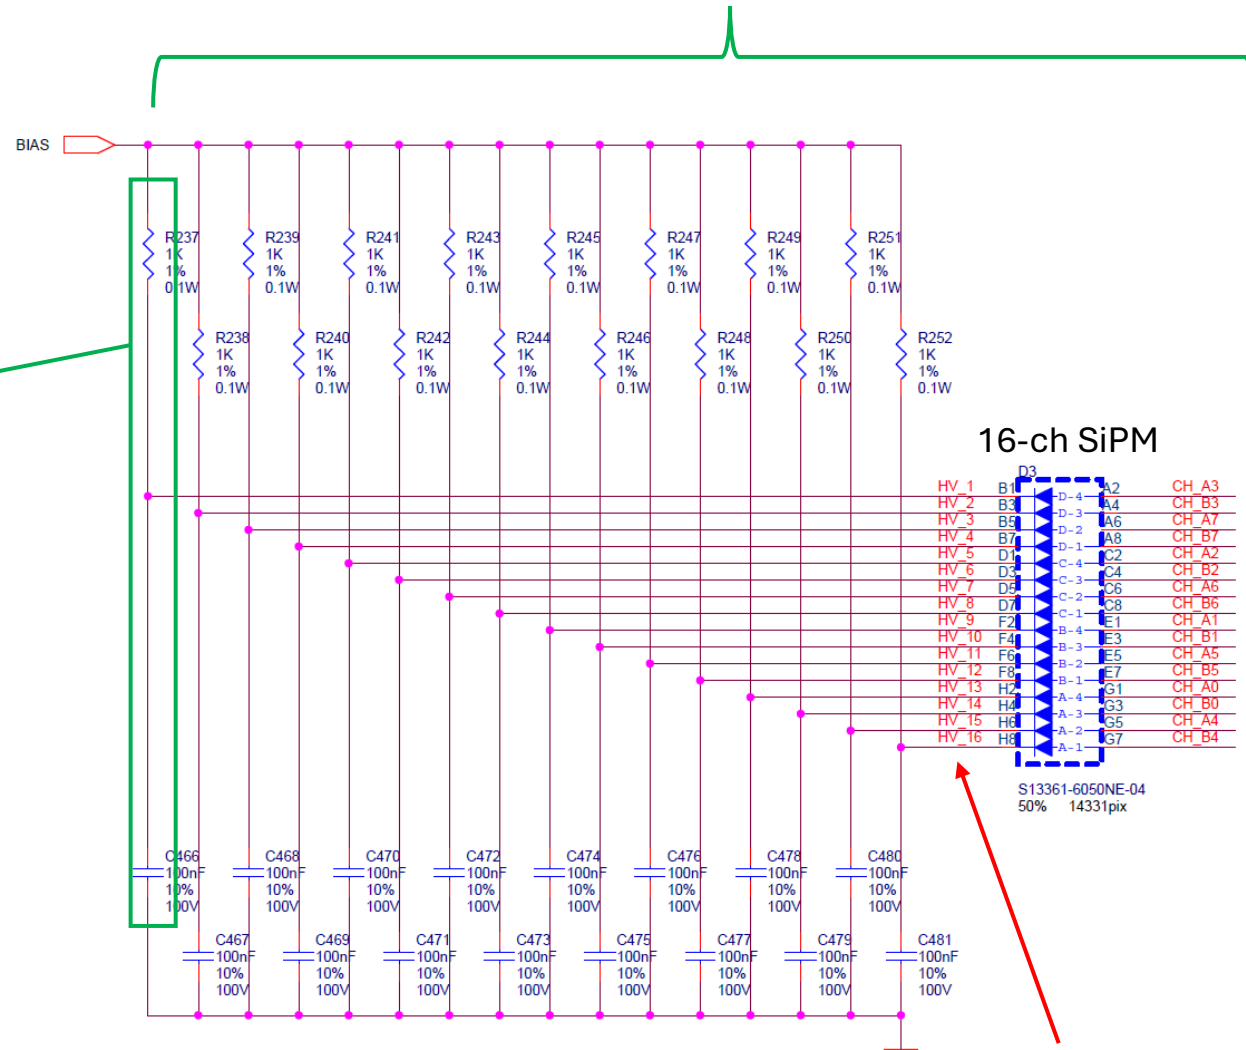
Bias distribution circuit

Repeated 4 x this 16-channels SiPM cell
= 64 channels on PCB

64 x 1K/100nF cells
on PCB bottom

Typical HV current in each HV_x cathode is very low (<100μA)
A short to GND on HV_x means $I_{BIAS} = V_{BIAS} / 1K \approx 5.7mA$

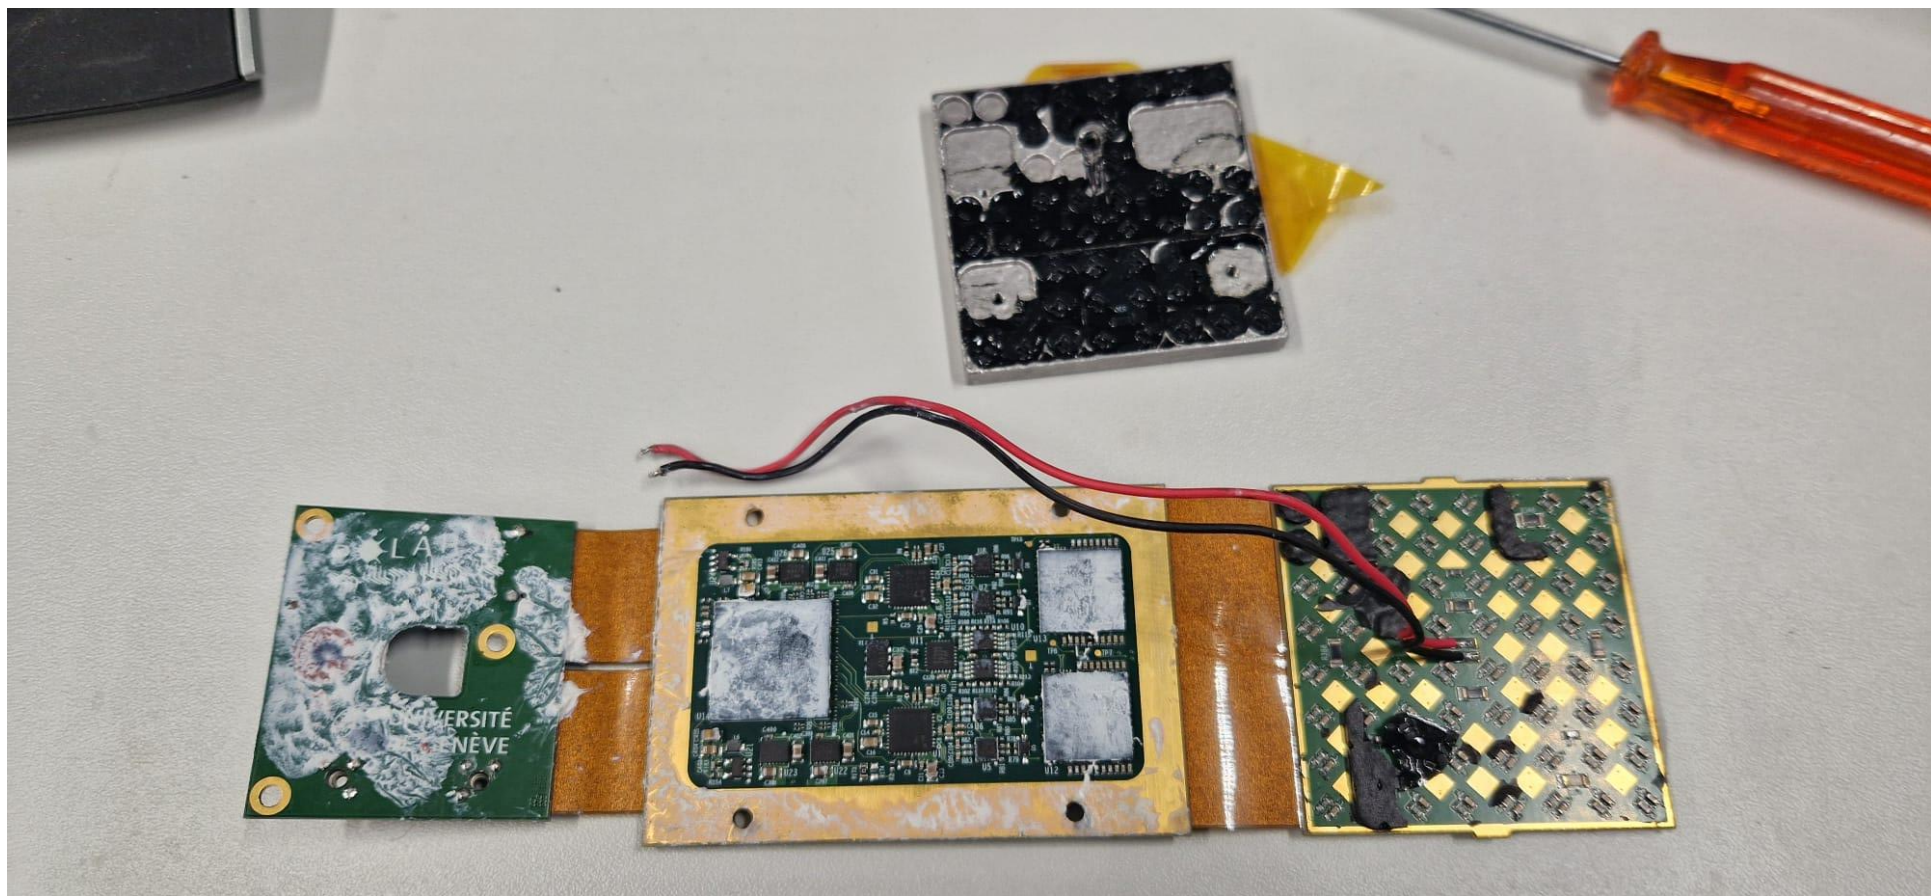
FEE dismounting

IR camera: 1K R215 heats when HV is on

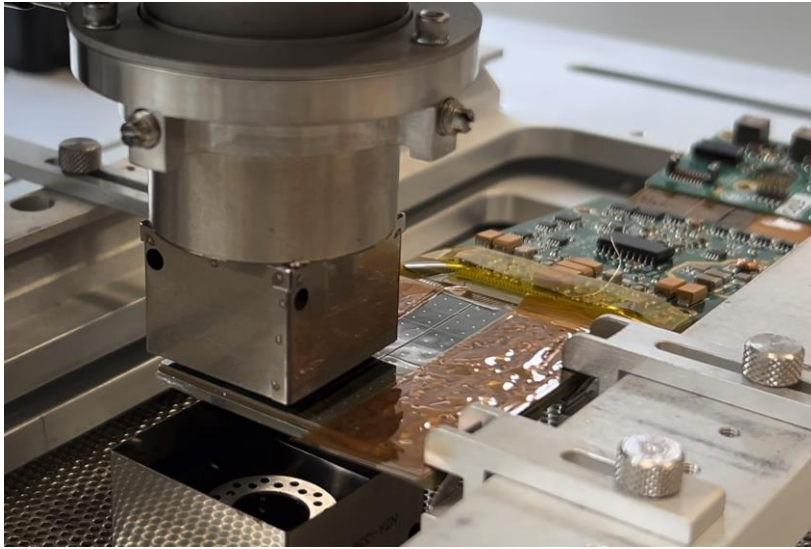
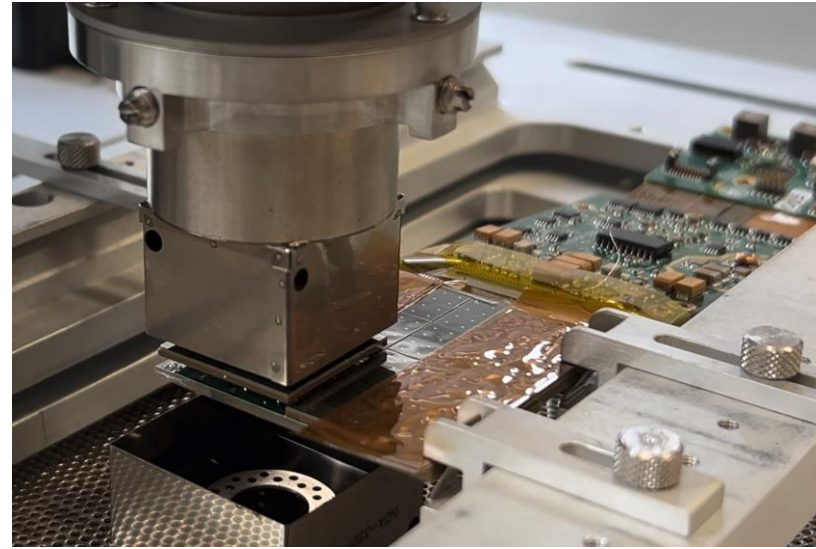
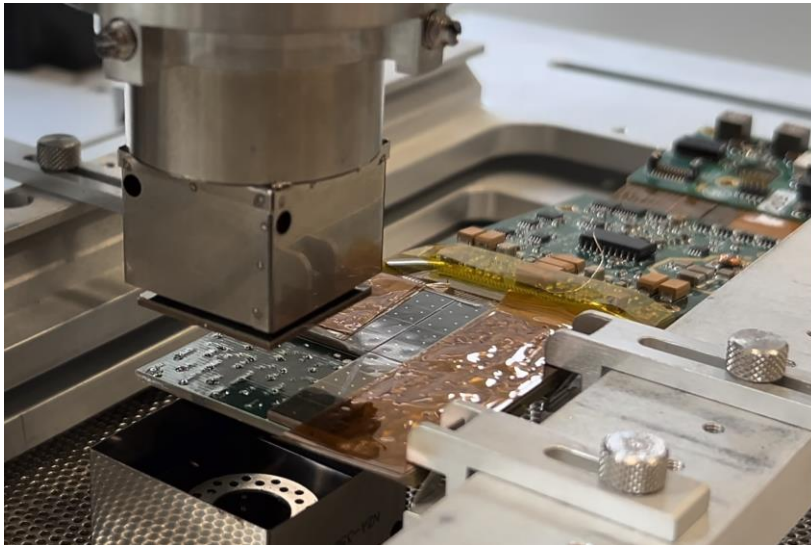
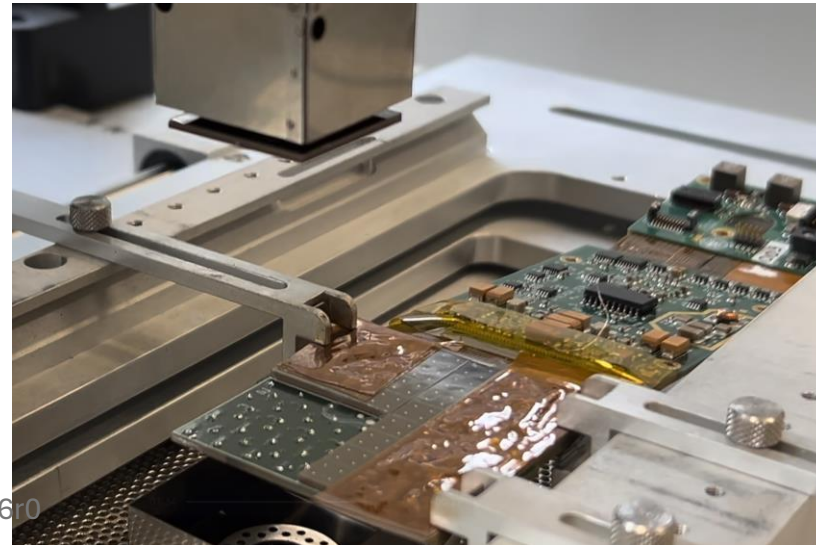
SiPM removal

Broken pad/
damaged SiPM
during dismounting

Same curve on bad
channel (red rectangle)
=> SiPM is not in cause
=> PCB failure

- As it is not possible to clearly identify the origin of the problem, we have decided to remove the SiPM array, the capacitor and 1K resistor (only PCB traces remain)
- The array still has to be measured.
- But the resistive connection between the HV11 line and GND is still present on the PCB and now on a very limited area : 1 small trace on BOT (yellow) + 1 through via to TOP + 1 small trace on TOP (green).
- A new IR measurement has been done.
- And X-ray examination has been done.
